NACA RM E51J10

EXPERIMENTAL INVESTIGATION OF AIR-COOLED TURBINE BLADES
IN TURBOJET ENGINEIX - EVALUATION OF THE DURABILITY OF NONCRITICAL ROTOR
BLADES IN ENGINE OPERATION

By Francis S. Stepka and Robert O. Hickel

Lewis Flight Propulsion Laboratory

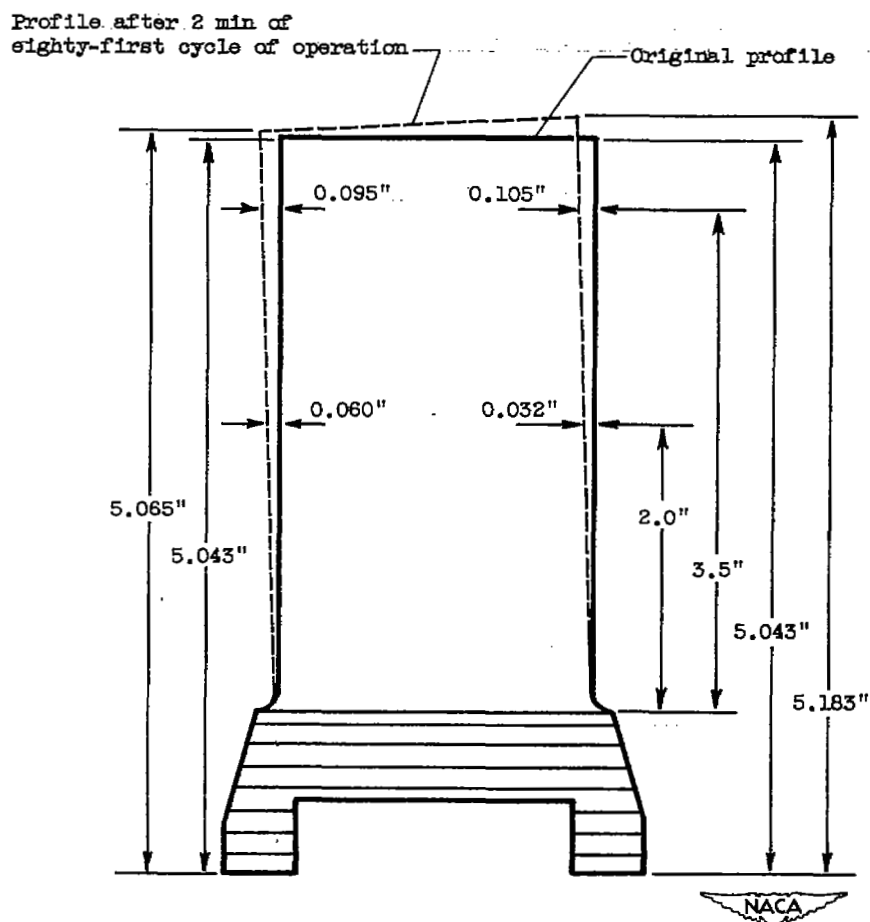
Configuration C. - One blade of configuration C (fig. 3) cast of SAE 4130 steel with no heat-treatment was installed in the turbine rotor for the endurance test. This blade was operated for 1 hour at both 11,000 and 11,500 rpm at a cooling-air to combustion-gas flow ratio per blade of 0.15. At the end of this time, the second and third tube inserts from the trailing edge, which were not completely in contact with the shell at the beginning of test, parted from the shell near the tip; nevertheless, the test was continued for a total time of 8 hours (4 hr at rated speed) when the second tube from the trailing edge broke approximately $1\frac{1}{4}$ inch from the base and damaged the tip of the blade as it came out of the cooling-air passage. An attempt to repair this blade was unsuccessful and it was removed from the rotor and replaced by a similar blade. Although a radiograph inspection of this second blade prior to installation revealed shrinkage and porosity above a third span length from the base, the blade was used in order to determine whether these defects had a serious effect on structural strength of the blade. After a total running time of approximately 31 hours (22 hr at rated speed) the test of this blade was terminated because of distortion and excessive creep at the trailing edge. The distortion of this blade after 2 minutes of the eighty-first cycle of operation as compared with a blade that had not been endurance tested is shown in figure 5. Small cracks at the leading edge, which are apparently hot tears, were also observed at the termination of the test. This excessive creep may have resulted because the blade was not heat-treated. Also the elongation may have been caused by malfunctioning of one of the engine components which occurred during the first 2 minutes of the eighty-first cycle and caused the effective gas temperature to reach a value of 1570° F, which is 120° F higher than that normally maintained for the endurance investigations. The engine was shut down immediately and the elongation of the turbine blades was observed.

Figure 5. - Distortion and creep of blade C2 (cast of SAE 4130 steel) after 2 minutes of eighty-first cycle of operation.
